GYLON EPIX® Style 3501-E

Case Study: Grease Production

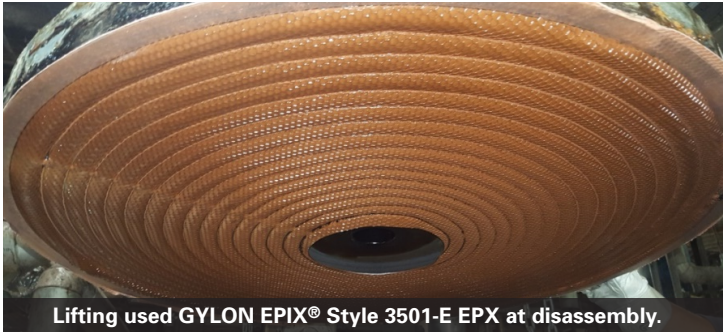
Lifting used GYLON EPIX® Style 3501-E EPX at disassembly.

Since the installation of GYLON EPIX® Style 3501-E, the sealability of whole heat exchanger system has been significantly improved, effecting the whole plant availability. After 6 months of seamless operation, the system was opened and the general appearance inspected. The gasket was found to be in excellent condition. No dismantling, no misplacement, no cutting into slices, no discolorization, no effect becoming brittle could be found and the gasket was not sticking to flanges at all. The customer is very pleased with the results and will specify GYLON EPIX® for this application.

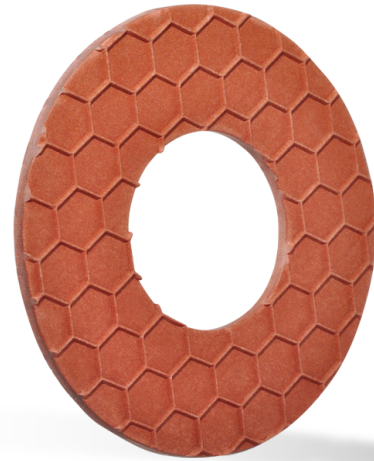
Prior solution: „damaged“

Prior solution: „sliced“

The customer has had leakage issues with the spiral heat exchanger which is fastened by outside mounted clamping screws (Bracket-screws). Based on the sealing surface, the screws are only providing low load and the whole system is exposed to daily thermocycles. Previously used gaskets had to be exchanged frequently and they were cut into slices by the separation bars of the spiral heat exchanger, causing leakage and turbulence (see pictures entitled "Prior solution").

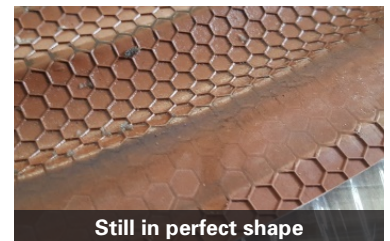
Still in perfect shape
