GUARDIAN® Bearing Isolator

Case Study: Application in Machine Tools

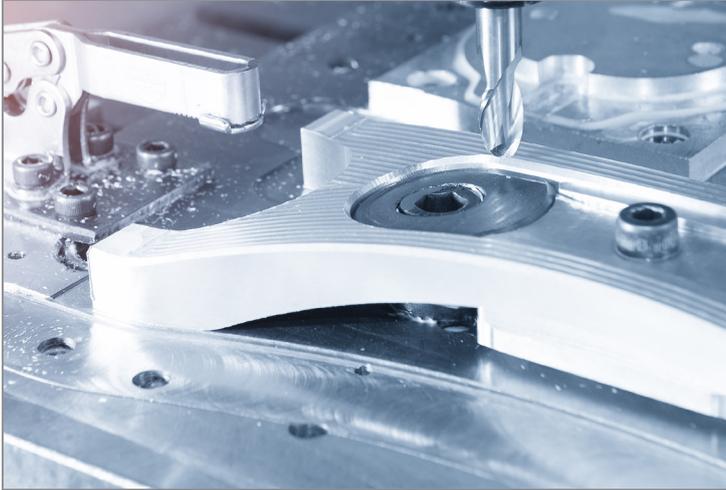
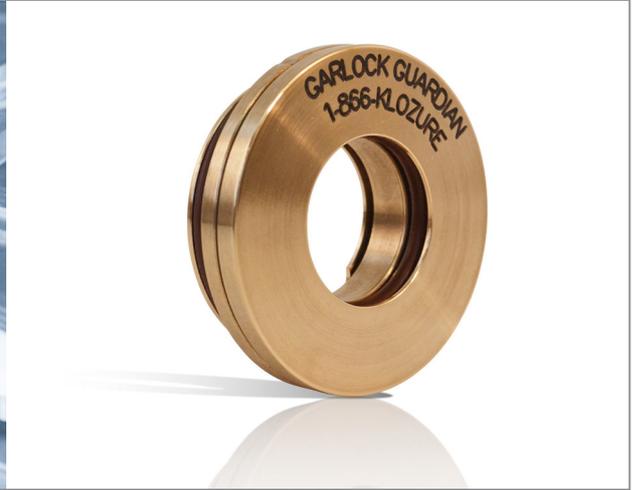
GUARDIAN® has been installed between the housings and their spindles. Bearing oil leakage and debris inclusions are eliminated now.

The Customer specified GUARDIAN® in all machines of a special model replacing original labyrinth seals.

The introduction of GUARDIAN® simplified the overall design and related installations. Machine reliability increased reducing the total cost of production.
